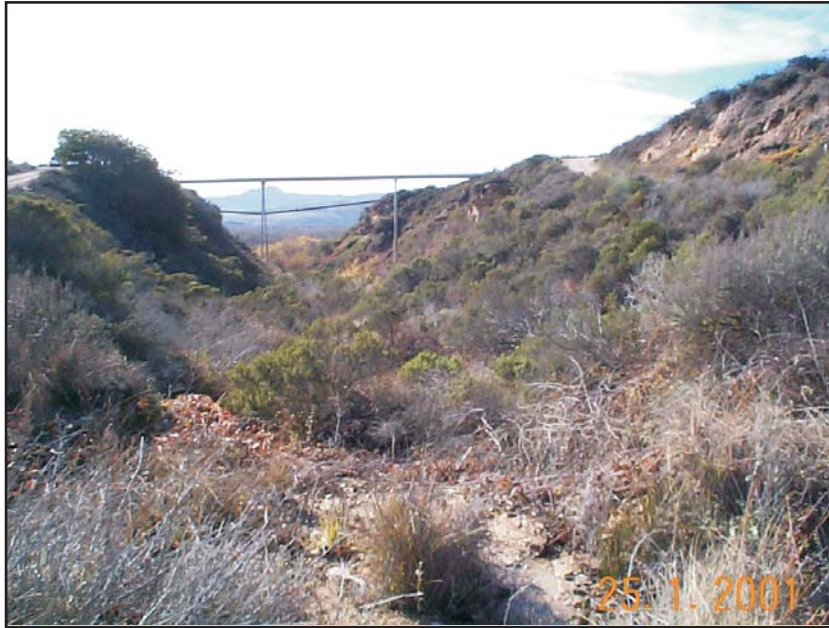
Figures 5.4-1: Photograph of Pipeline Route Crossing Small Drainage Feature Near Basin 4.

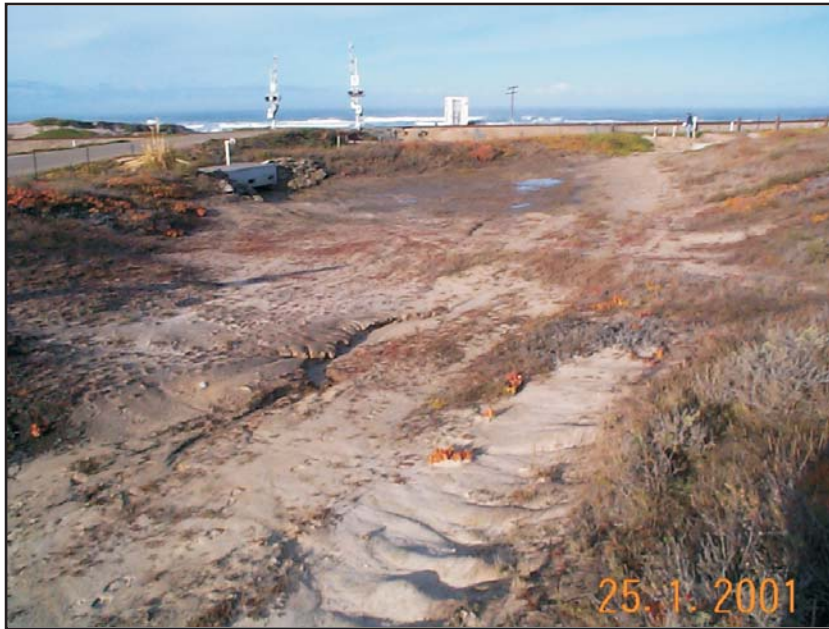
Figures 5.4-2: Example of a Catchment Basin (Basin 1) Adjacent to Onshore Portion of the Pipeline Route. (A weired Concrete Outlet is Shown Near the Upper Left Corner of the Photograph.)
